REPORT NUMBER: 214-CAL-06-04

**SAFETY COMPLIANCE TESTING FOR FMVSS 214  
SIDE IMPACT PROTECTION  
INDICANT**

**HONDA OF CANADA MFG.  
2006 HONDA CIVIC  
2-DOOR COUPE**

**NHTSA NUMBER: C65304**

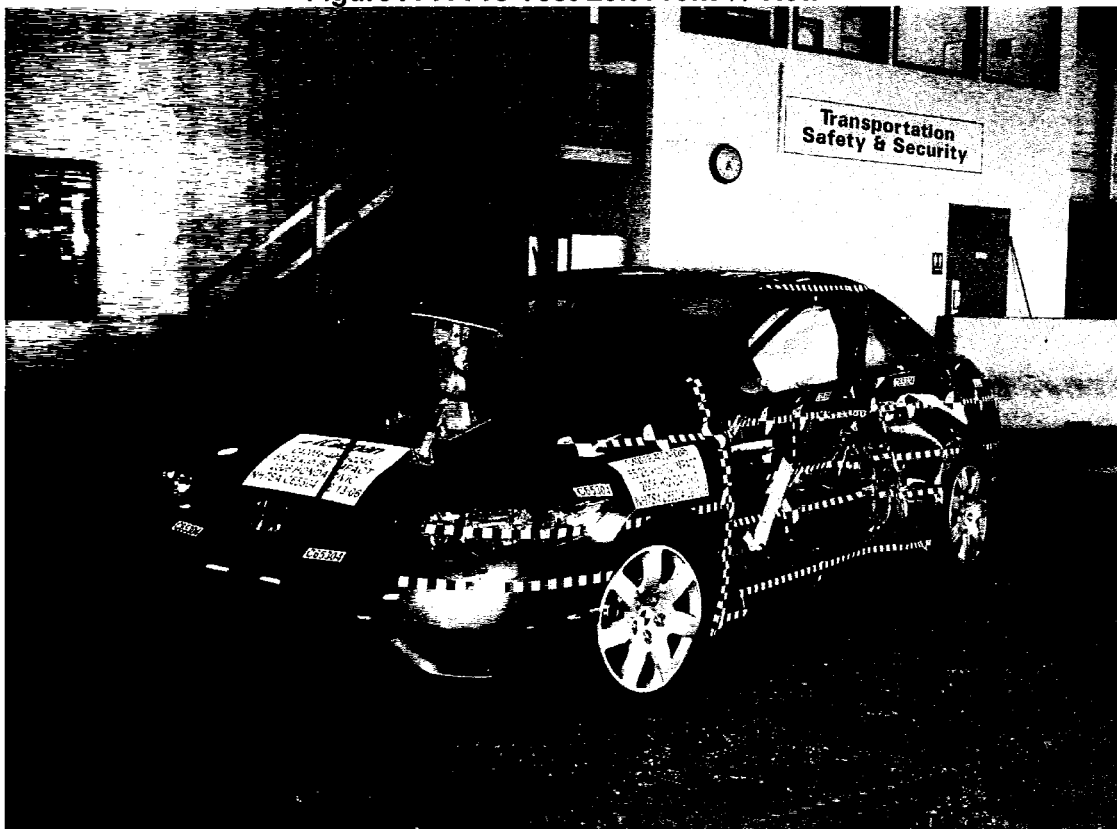
Figure A-8: Post-Test Left Front  $\frac{3}{4}$  View

| Critical Areas of Performance | Observations and Conclusions |
|---|---|
| Windshield Damage | The upper left side of the windshield cracked |
